Who Killed the Cover

A Chemical Guide
19/02/2018 v2 daft

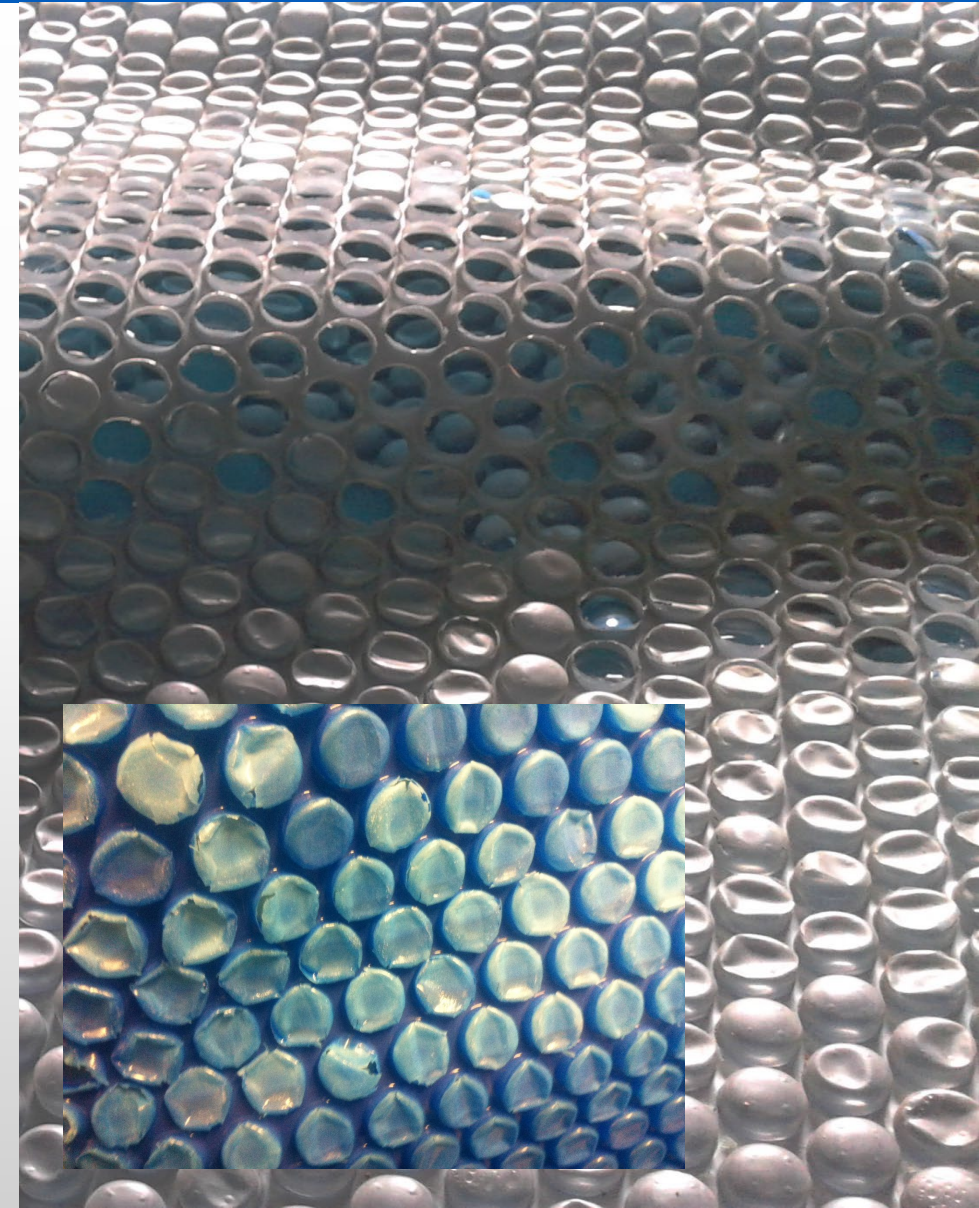
Chemical Degradation

- Most issues involving premature degradation are the result of elevated chemical levels within the pool.
- Frequently, a sudden deterioration of the cover can be the result of a shock treatment.
- Noticeable effects:
 - Bleaching of the underside of the cover.
 - Bleaching of the hemming/edge.
 - Material has turned brittle - in particular on the bubble layer.
 - High residue amounts on the cover.
 - Oxidation of eyelets.
 - Strong chlorine smell.

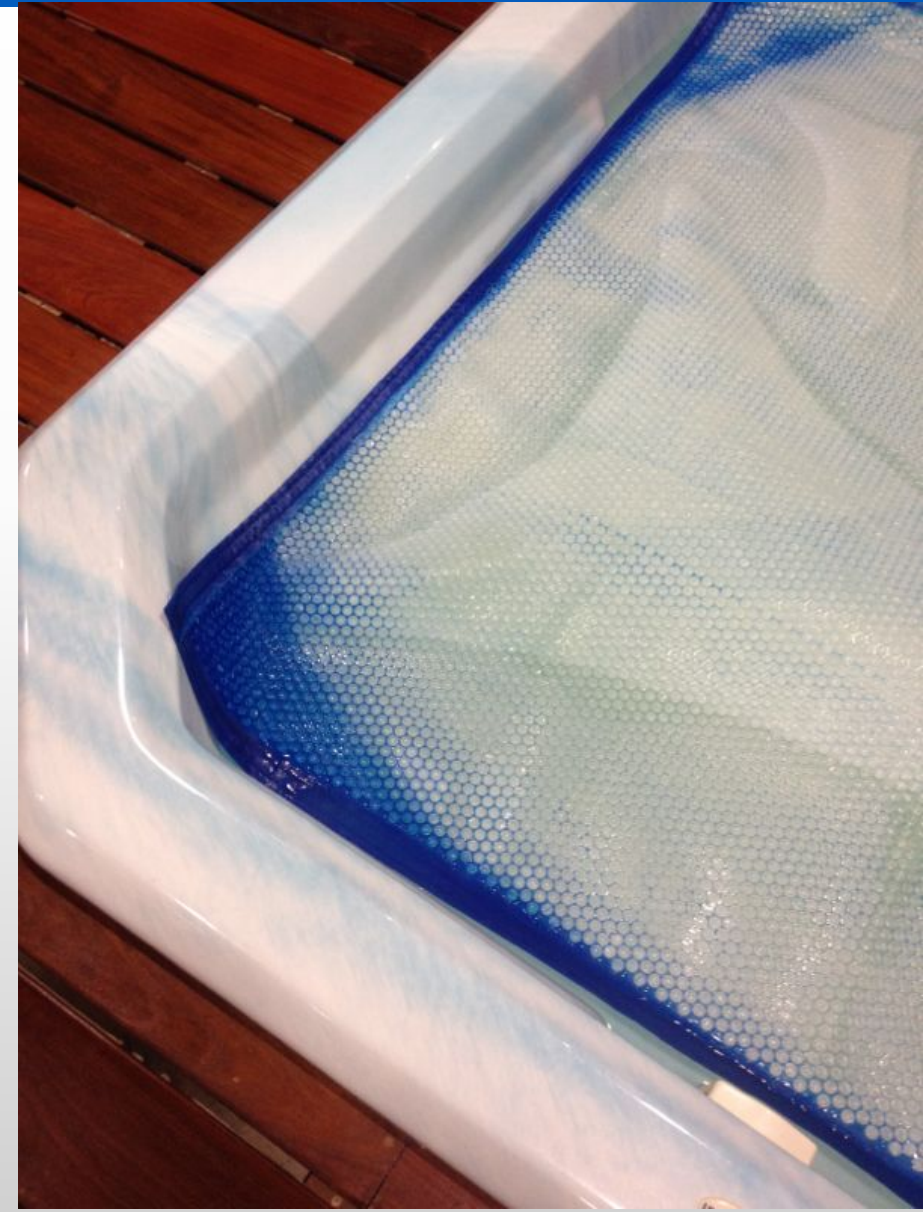
Bleached pigment

When a cover has been bleached, this is the result of high chemical level and is often exacerbated by high temperatures such as on a hot tub.

The first indication of chemical degradation will be the bubbles on the underside of the cover.

Bleaching of the cover will normally be noticed once the bubble layer has started to become brittle and crack easily.

In extreme cases like in this image the cover has been used on a hot tub and the combination of high chemical levels and higher temperatures have resulted in a dramatic change in the cover's appearance and properties.

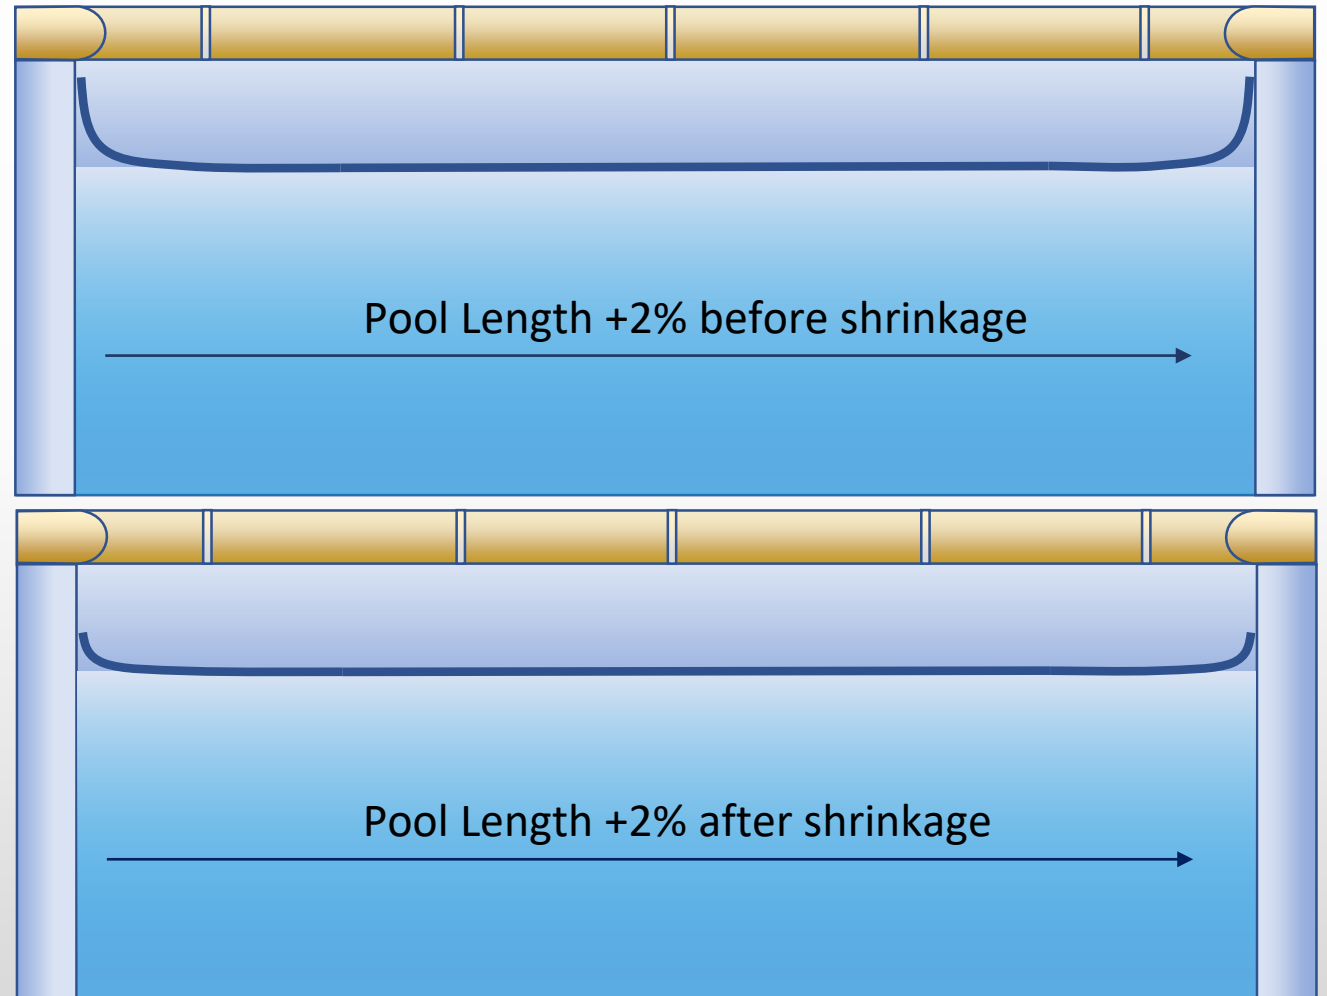
Shrinking Cover

Shrinkage of the cover can happen and is usually exaggerated by bubble swell.

Shrinkage is the result of the polymer in the material releasing stress as it gains molecular mobility.

As the material heats up the polymer gains the ability to release any stresses held within the material.

As a result of this Plastipack aims to remove as much stress from the material as possible. Because of this, should shrinkage be triggered, the material should only shrink between 1% and 2% of its total length.

It has become a common part of industry's best practice to oversize the cover by 2% in its length to allow for a small amount of shrinkage as the cover settles on the pool.

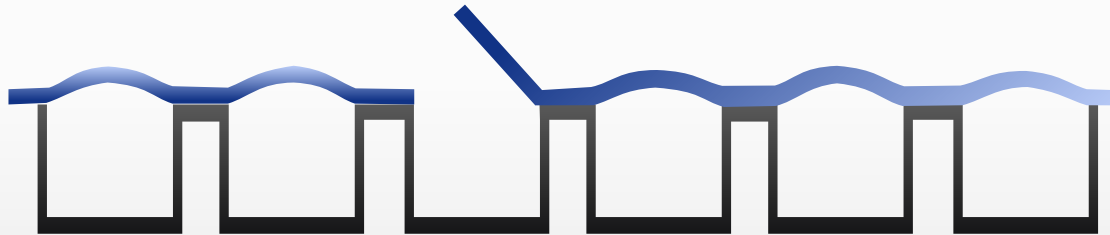
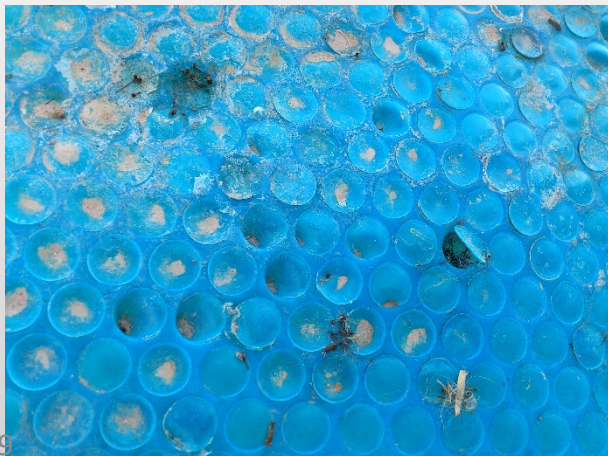
Top Hating

Top hatting is where the flat top surface of the cover starts to come away from the material around the bubble profile.

Top hatting usually occurs as the cover starts to degrade either chemically or from UV as they reach the end of their lifespan.

However, this issue can also present itself from overheating. As discussed in the section “Overheating on the Reel System”, a cover could reach up to 80°C, which could cause permanent damage to the cover, even an issue such as top hatting.

This is most often seen in materials with a dark/opaque top surface.

With a well monitored chemical regime and appropriate storage provisions, this can often be prevented.

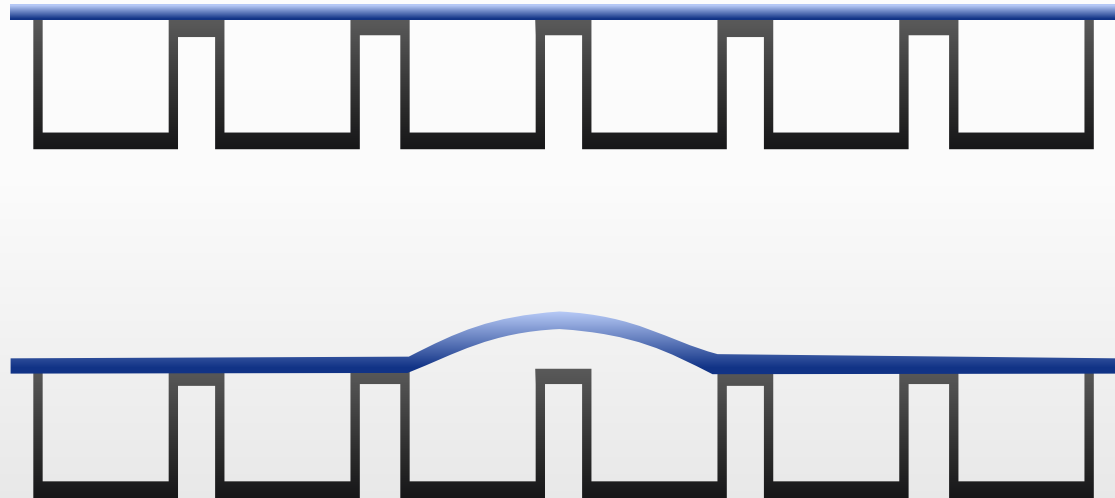
Delamination is incredibly rare and most often is the result of the cover overheating when being stored off the pool.

When folded or left exposed on a reel system, the material quickly heats up and causes the air within the bubbles to expand.

In extremely rare cases this can result in the air expansion forcing the layers of material at the land area of the bubble separating.

This can be avoided with the implementation of a reflective storage sheet.

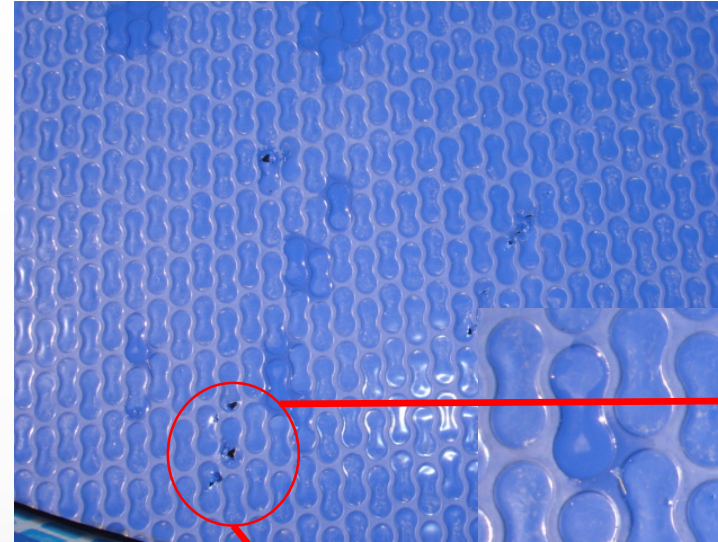
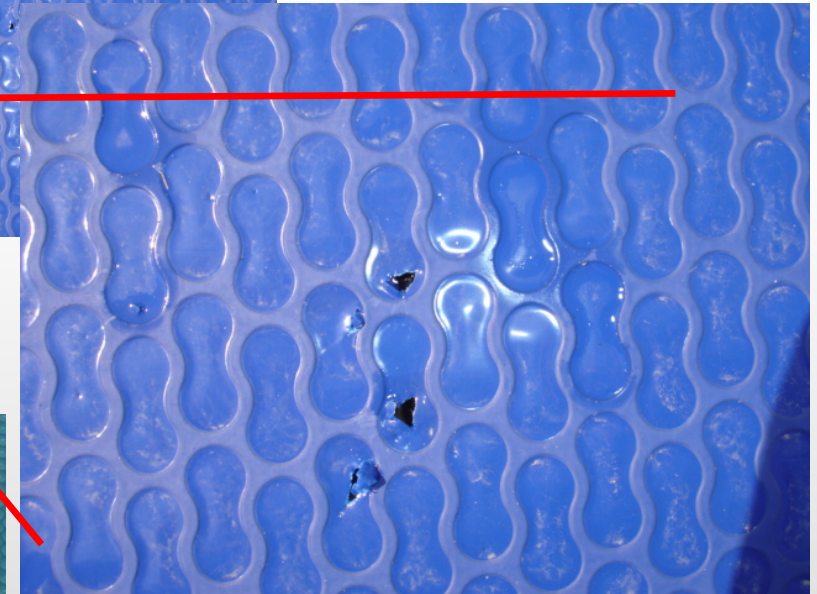
Herring Gull Attack!!

This is more common than would be imagined. Small groups of punctured or torn holes are often caused by birds.

We have found that a few CD's hanging from a string will cause reflections that discourage the birds from lingering around the pools.
