Wrinkling of Liners

**AlkorPlan**

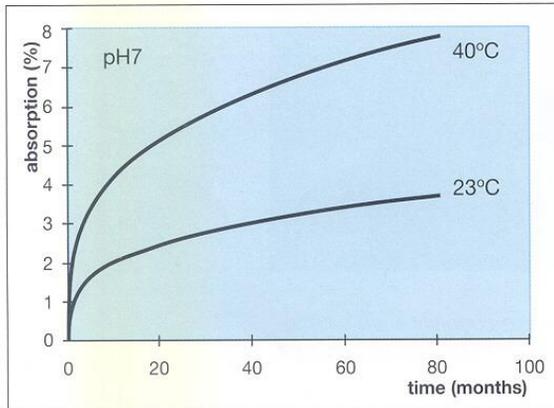
Tests have been carried out in water containing 1-2 PPM of chlorine and 30-50 PPM of stabiliser

This diagram shows higher levels of water absorption at higher temperatures.

PVC absorbs moisture and water treatment chemicals. With normal swimming pool conditions, absorption will not exceed 5% of the original weight of the liner. However, with high temperatures and low pH the level of absorption could be much greater.

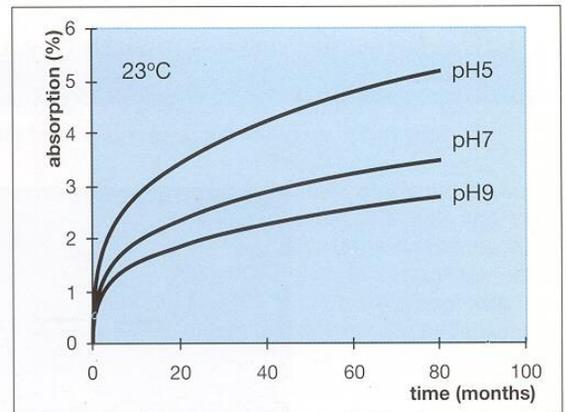
This diagram shows higher levels of water absorption at lower levels of pH.

Pollution and water treatment chemicals will also influence absorption. In salt water, absorption will be lower than in water containing fewer minerals, while high chlorine levels increase absorption, especially when combined with low pH.

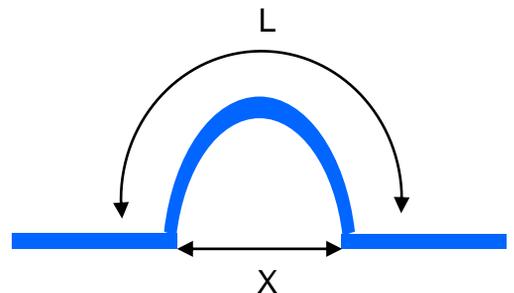
Examination of a fold shows that the length L is at least 50% greater than the original length X . To achieve this level of growth the folded area would have to have absorbed some 130% of its original weight. As this is physically impossible, the liner on either side of the fold must have slipped towards the fold

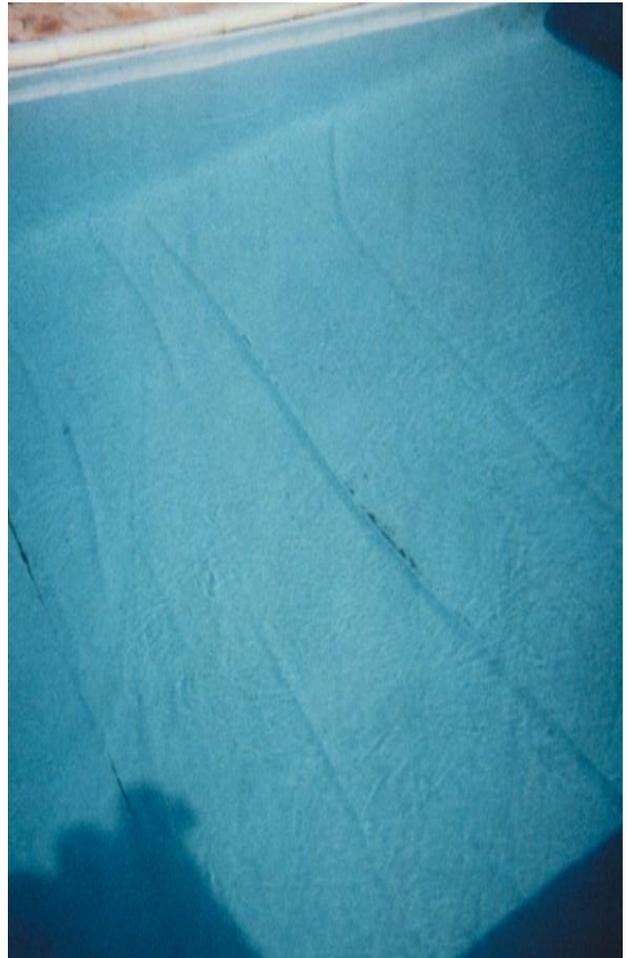
In the picture on the right, the presence of large folds indicates that significant quantities of water are present behind the liner. In effect, the liner is “floating”. There may be leaks at the joints between liner and water inlets or outlets, or maybe there is a ground-water problem.

The main cause for low friction between the liner and the pool structure, is the presence of water between them. This water can be condensation water (in the case of heated pools and/or cold structures) or it can come from the infiltration of groundwater.

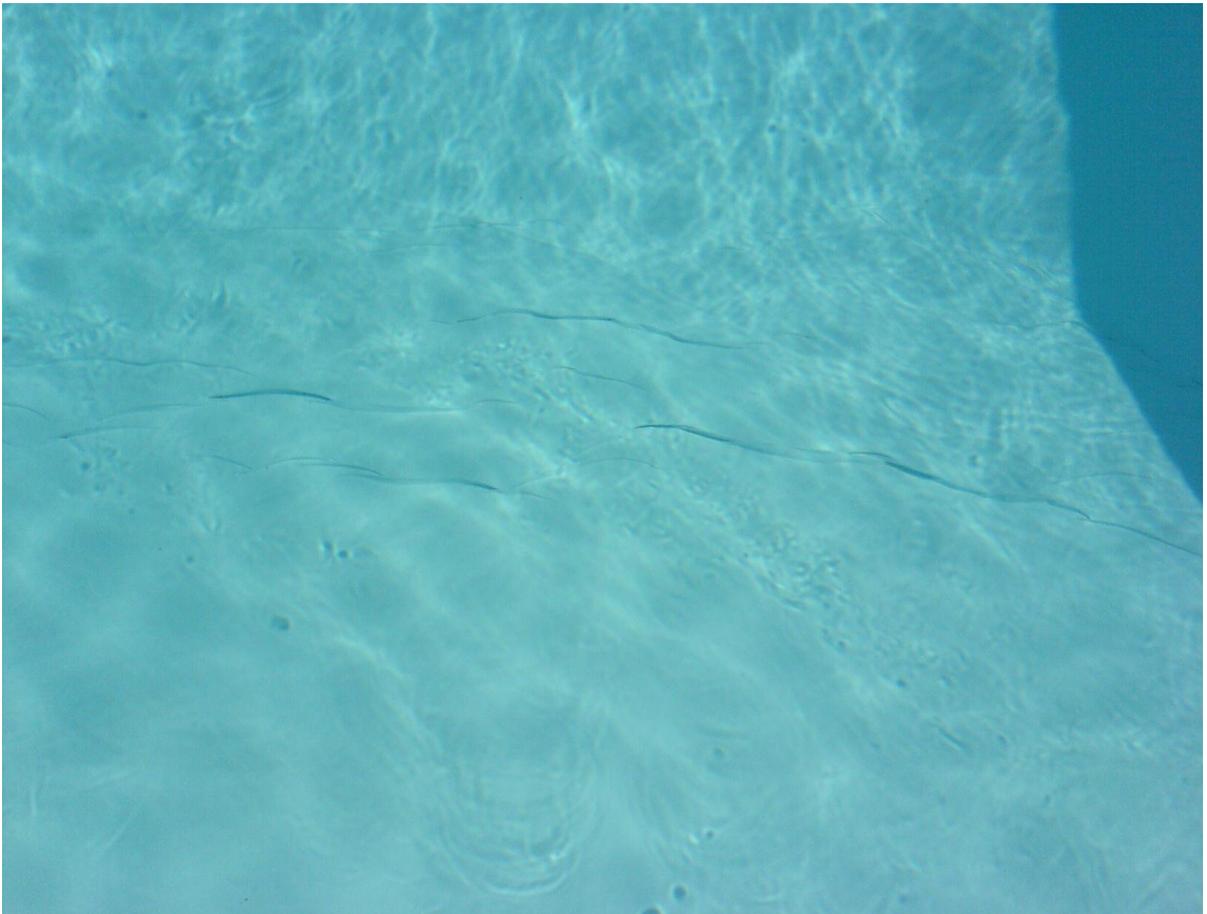
On the picture below, sharp creases are visible. These are a feature of a temporary ground water problem. There had been some kind of water infiltration behind the liner, which has led to liner displacement and the formation of folds; as the ground water soaks away, the folds are flat and sharp.

Such creases may appear after heavy rain showers. When the immediate area around the pool is flooded, there can be water infiltration between the liner and the pool structure creating a fold. A couple of days later, all this water will have disappeared. The weight of pool water on the liner does not allow the membrane to move back to its original position and without the water behind it the fold collapses leaving a creased liner.

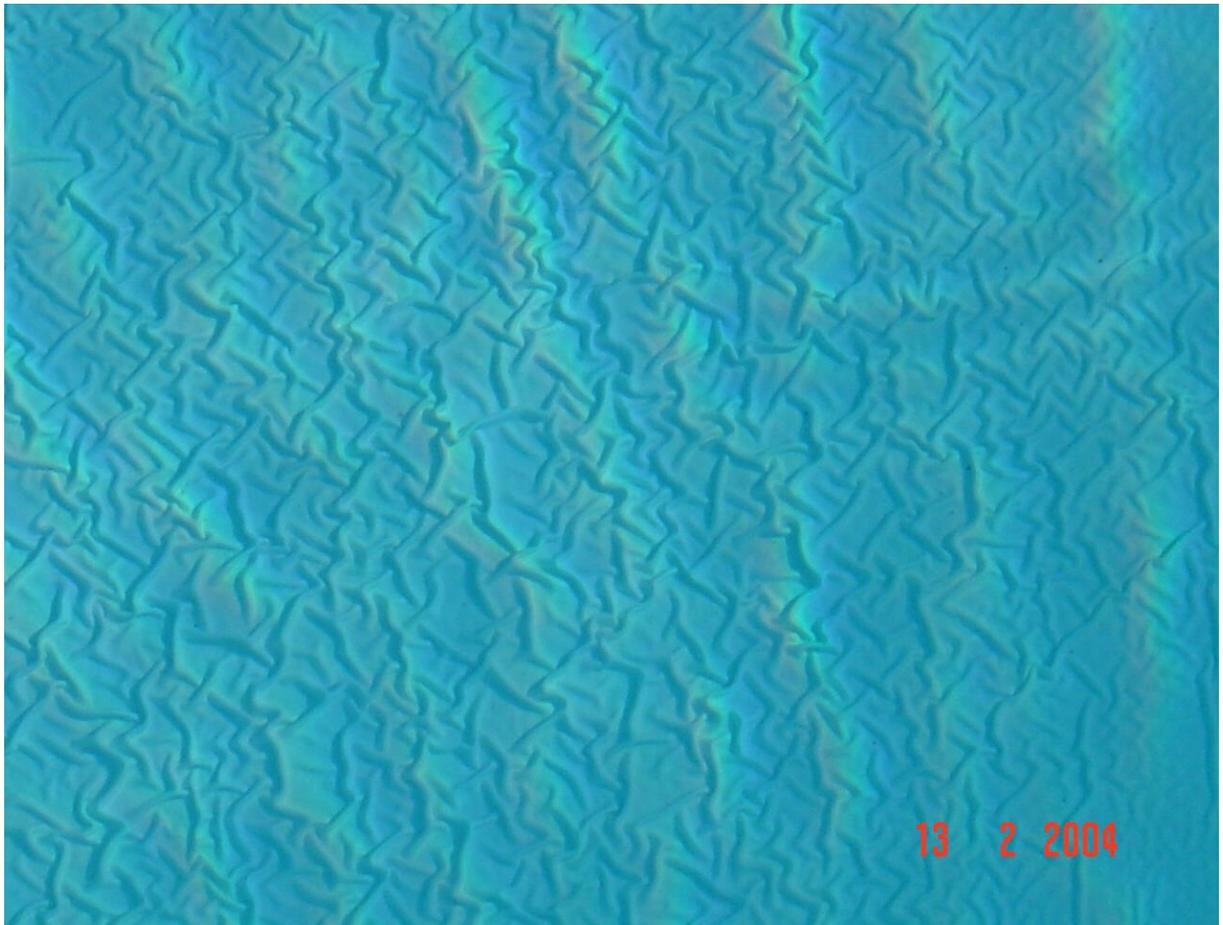
Large folds 30cm or more apart, indicate liner displacement with the presence of water behind the liner. Alternatively, situations, such as the illustration below, can occur where a number of small creases develop much closer together. This indicates that abnormally high moisture absorption has occurred, without excessive movement of the liner.

As already stated, a high degree of swelling of the membrane can be caused by high water temperature and/or high levels of chemicals in the pool water. Direct contact between chemicals and the liner is particularly likely to cause this kind of problem.

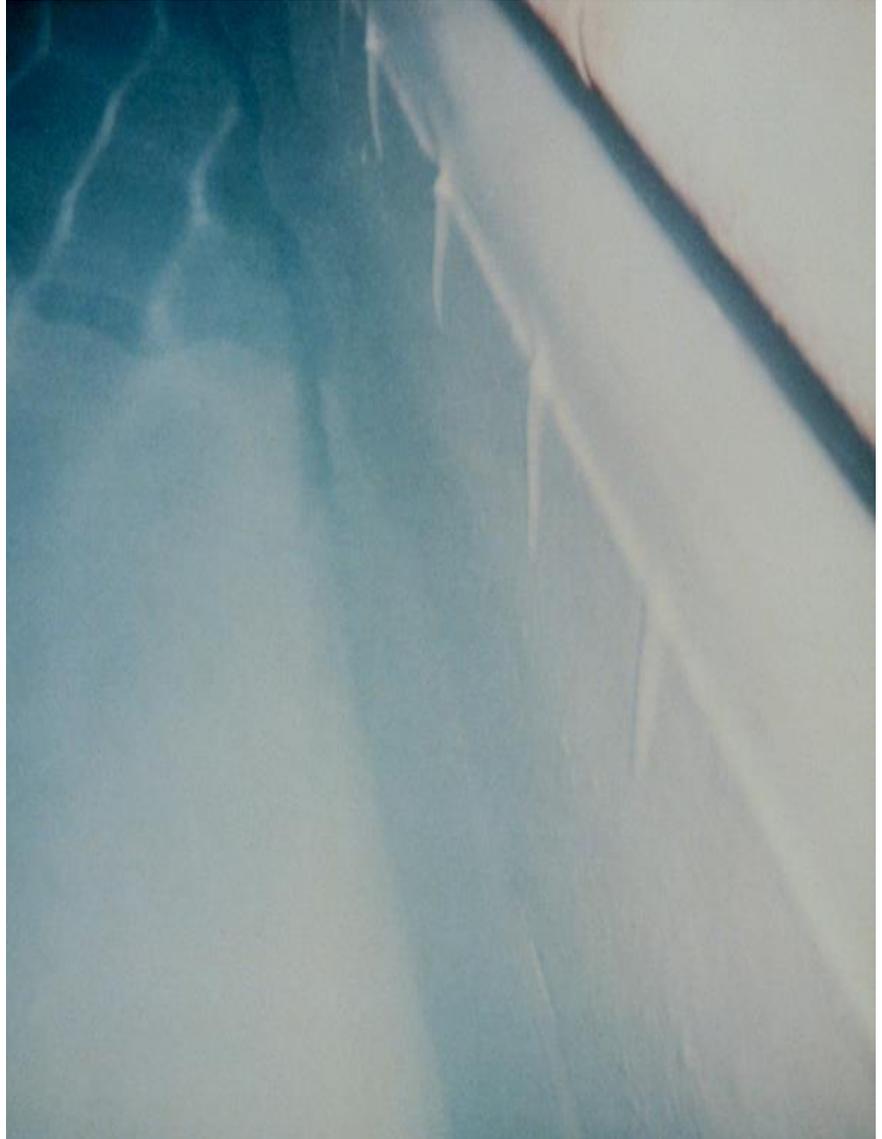
If however the supporting structure is very smooth and waterproof (e.g. plastic or metallic wall panels), this small quantity of humidity will form a slippery film between the liner and the pool structure.

In the picture on the right one can see that the liner material close to the water level (where there is less water pressure) has been able to slip and form vertical folds.
