Groundwater issues and your Aquaflex swimming pool liner

This document has been made by Aquaflex to raise awareness of the potential issues concerning groundwater, and how it may affect a PVC swimming pool liner.

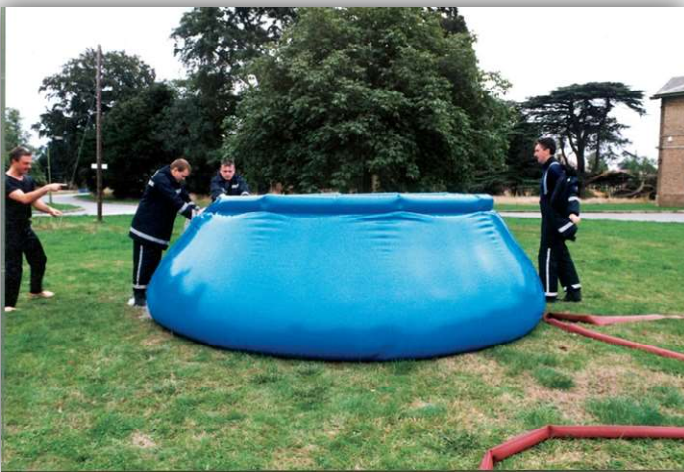
Standard Easitank – 3000 gallons

Aquaflex strives to continue to supply a high level of service and quality, and has made the decision to supply **only 1** Aquaflex Easitank (water storage tank) for every installation*. The Easitank will be filled by Aquaflex, using the homeowner's water supply, and emptied into the pool (by Aquaflex) as the final part of the liner installation. This will be applicable to all pools between October - April, regardless of groundwater issues.

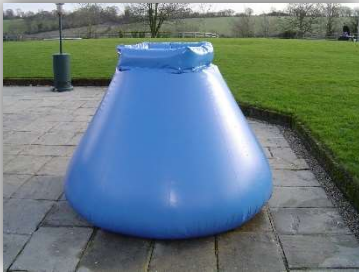
The 'Spa' Easitank - is the baby of the family, holding about 450 gallons (approx 2,000 ltrs) and is able to fit into smaller spaces, being only about 2m in diameter.

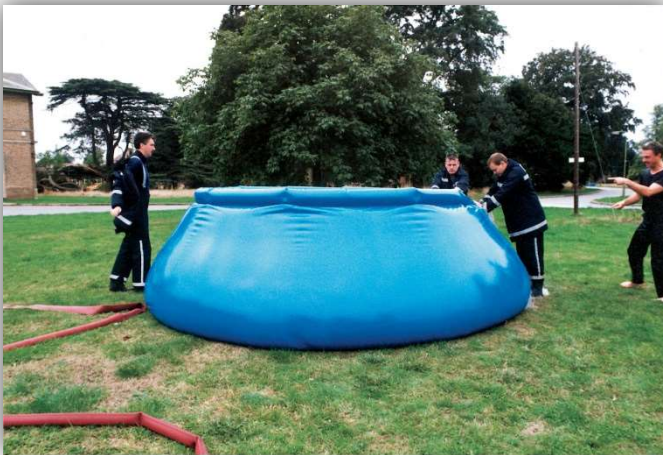
The 'Standard' Easitank - holds about 3,000 gallons (approx 13,000 ltrs) and measures approximately 4.25m across.
