Who Killed the Cover

A Chemical Guide
19/02/2018 v2 daft

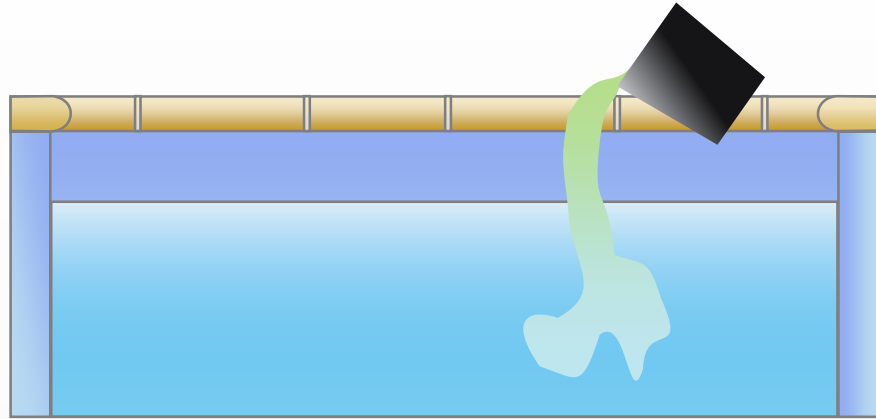
Chemical Degradation

When shock dosing a pool, the sanitiser levels are elevated from the normal 2 to 4ppm (parts per million) to as high as 10ppm or even up to 30ppm when removing algae blooms.

The increase in sanitiser burns off foreign matter in the pool and allows the by-products such as chloramines to gas out of the pool.

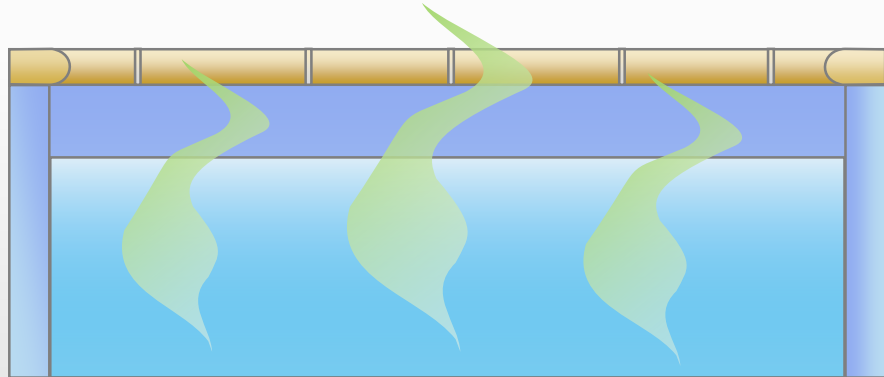
As a result active sanitizer levels in the pool quickly return to balance.

However, when a pool cover is left on during a shock dosing, the cover is exposed to the intense levels of the oxidant as well as trapping the by-products under the cover reducing the efficiency of the chemical treatment.

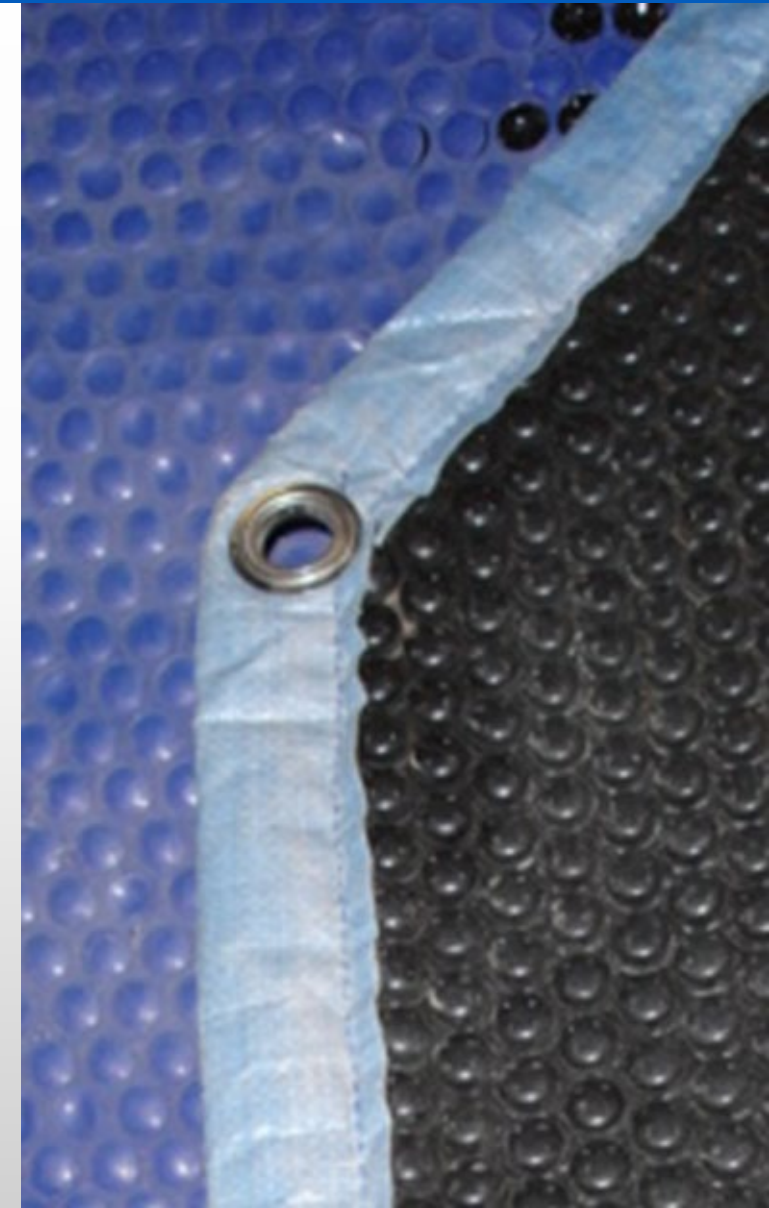
Chemical Degradation

- Many automatic dosing systems and salt water chlorinators work by releasing or creating a set amount of chlorine and a set rate.
- When a new cover is placed onto such a system, it is important to monitor the water balance and adjust for the savings the cover provides.
- When placed on a pool a cover will prevent debris, reduce chemical photolysis and in some cases inhibit algae growth. These factors reduce the chemical demands of the pool.
- As a result, if not adjusted for the covers savings, the pool's chemical levels can inadvertently elevate.
- By monitoring the pool for a few days it is possible to reduce the chemical demand of the pool while ensuring the performance of the cover.
